Manhole Inspection Summary

Manhole # S55AA_001MH

Insp Date: **3/11/10 2:30 PM**

Location Address: **E. Monument st**

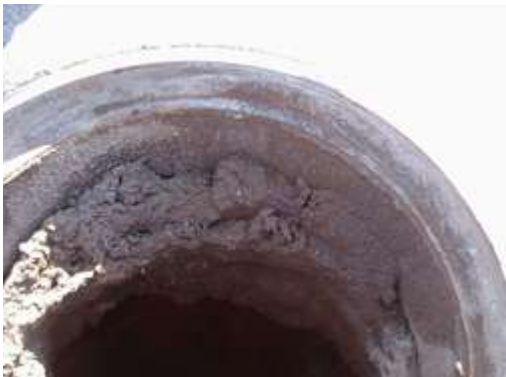
Defect 1

Infiltration: ☐ None ☒ **Joint** ☐ Cracks ☐ Mortar ☐ Roots ☐ Wall

adjustment joint

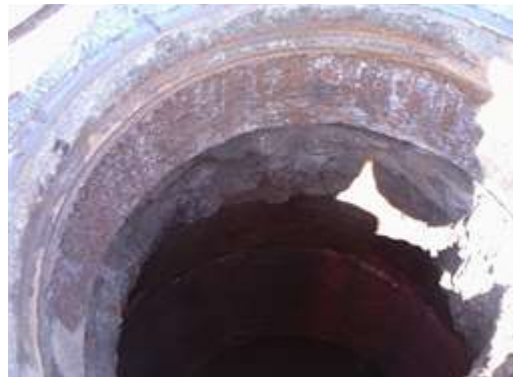
Defect 2

Frame Offset: **4** (in.) Condition: ☐ Sound ☐ Cracked ☒ **Leaks**

frame leaks

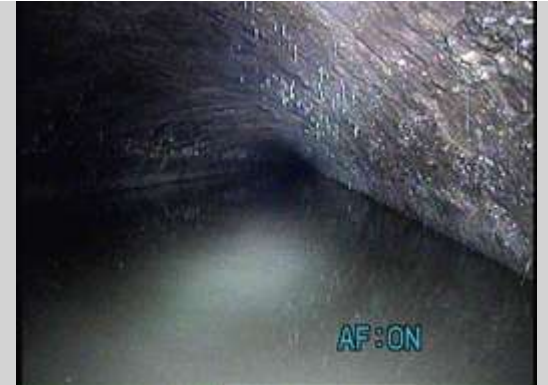
12 O'Clock Outflow

72 in. Circular Gravity Sewer
Pipe Out @ 12 O'Clock

Pipe Height: **75.6** (in.) Rod and Bar (Angled)
Pipe Material: **Unknown** ☐ Pipe Lined
Invert Depth: **13.67** (ft.) Flow Characteristics: **Fast**
Deposits: ☒ None ☐ Mud ☐ Sludge ☐ Debris ☐ Grease
Silt Depth: (in.) Deposits Extent:
Infiltration: **None** Pipe Seal Cond: **Unknown**

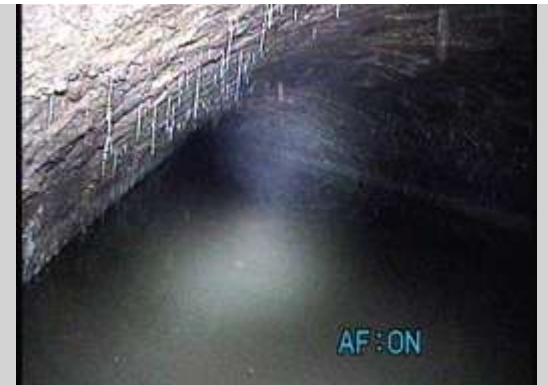
6 O'Clock Inflow

72 in. Circular Gravity Sewer
Pipe In @ 6 O'Clock

Pipe Height: **75.6** (in.) Rod and Bar (Angled)
Pipe Material: **Unknown** ☐ Pipe Lined
Invert Depth: **13.42** (ft.) Flow Characteristics: **Fast**
Deposits: ☒ None ☐ Mud ☐ Sludge ☐ Debris ☐ Grease
Silt Depth: (in.) Deposits Extent:
Infiltration: **None** Pipe Seal Cond: **Unknown**
